# Manhole Inspection Summary

Manhole # S21I\_\_038MH

Insp Date: **9/21/07 9:08 AM**

**Location** Address: **1703 LEMMON ST**

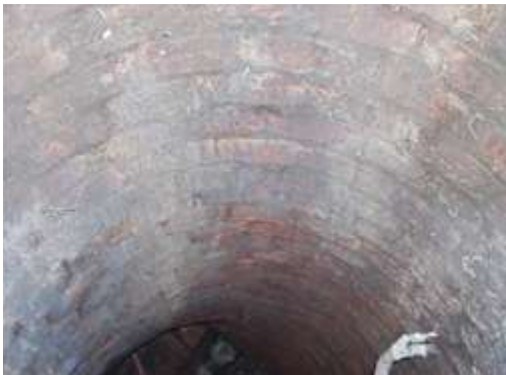
Defect 4

Infiltration: ☐ None ☐ Joint ☐ Cracks ☐ Mortar ☐ Roots ☒ **Wall**

INFILTRATION OF THE CORBEL WALL

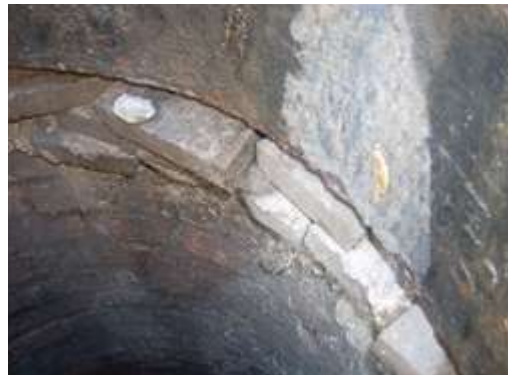
Defect 3

Condition: ☐ Sound ☒ **Cracked** ☐ Root Intrusion ☒ **Loose Brick** ☒ **Deteriorated**

LOOSE BRICKS IN THE CHIMNEY

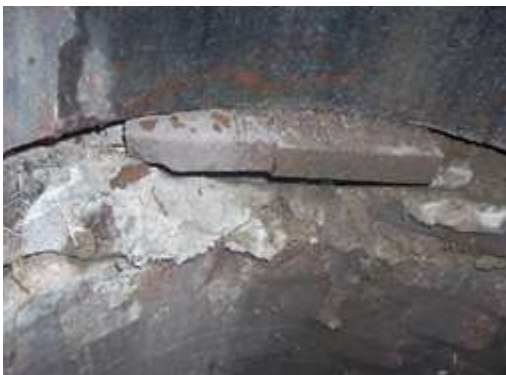
Defect 2

DETERIORATED AND CRACKED CHIMNEY

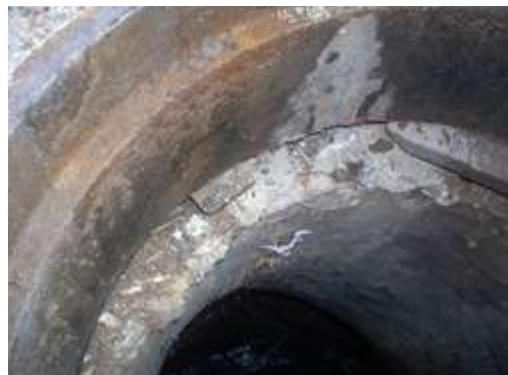
Defect 1

Offset: **2** (in.)

FRAME OFFSET

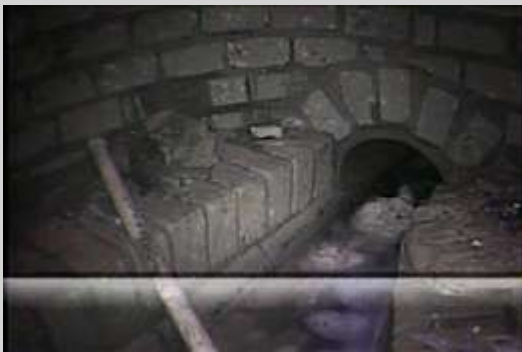
12 O'Clock Outflow

Pipe Height: **8.4** (in.) Rod and Bar (Angled)  
Pipe Material: **Clay** ☐ Pipe Lined  
Invert Depth: **11.20** (ft.) Flow Characteristics: **Slow**  
Deposits: ☐ None ☐ Mud ☐ Sludge ☒ **Debris** ☐ Grease  
Silt Depth: **2** (in.) Deposits Extent: **Medium**  
Infiltration: **None** Pipe Seal Cond: **Sound**

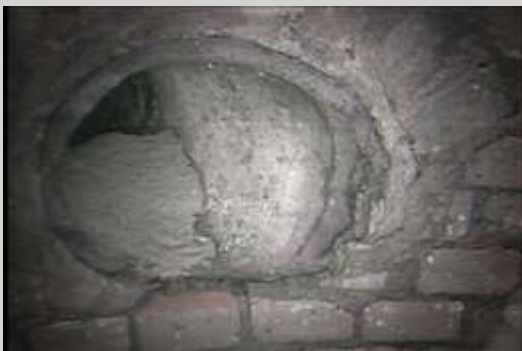
3 O'Clock Inflow

Pipe Height: **9.6** (in.) Rod and Bar (Angled)  
Pipe Material: **Clay** ☐ Pipe Lined  
Invert Depth: **8.46** (ft.) Flow Characteristics: **Slow**  
Deposits: ☒ **None** ☐ Mud ☐ Sludge ☐ Debris ☐ Grease  
Silt Depth: (in.) Deposits Extent:  
Infiltration: **None** Pipe Seal Cond: **Sound**

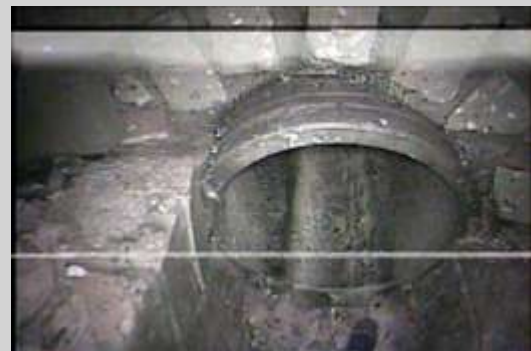
Drop In @ 3 O'Clock

Drop: **Outside** Rod and Bar  
Angled: **Yes** Reading: **9.56** (ft.)  
Inv Depth: **10.56** (ft.)  
Drop Condition: **Open**
